TRECOM TECHNICAL REPORT 63-10

Automatic Light Aircraft Readiness Monitor

Project ALARM

VOLUME I

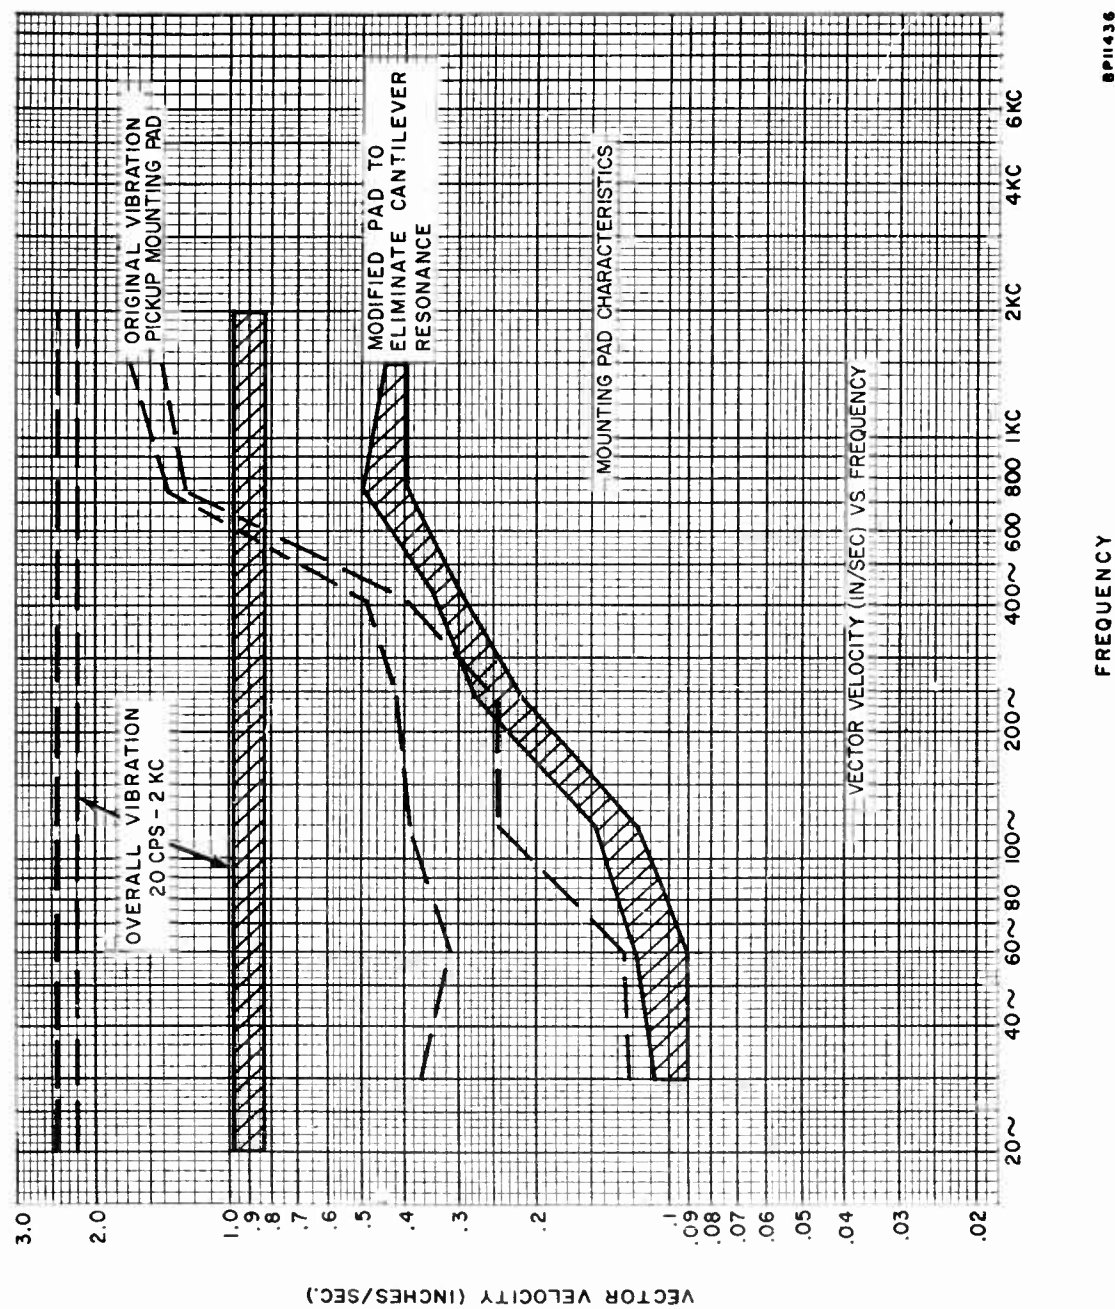
Prior to actually commencing the malfunction test sequences on the turbine engine, an investigation of the forward engine vibration pick-up was made as a result of an analysis of previous data recorded from that channel. It was suspected that the pick-up mounting pad arrangement was creating some resonances which were masking actual vibrations. A modified pad was manufactured and the results are shown in Figure 25. This modification will alter the actual vibration levels as recorded during Operational Tests of this channel, but it is felt that the relative amplitude differences at the various flight attitudes are still valid. The modified pad was used throughout the Malfunction Tests.

FIGURE 25. COMPARISON OF ORIGINAL AND MODIFIED FWD ENGINE PICKUP

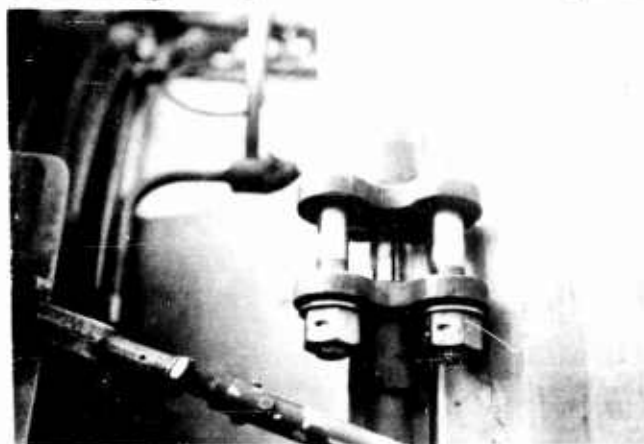
Figure 27. Engine V-Band Coupling Clamp (Loosened), Excessive Engine Vibration Malfunction Test.

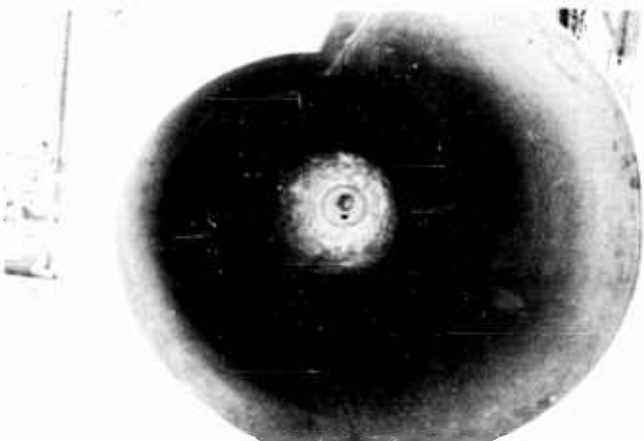
Figure 28. Engine Exhaust Opening Showing "Bishop's Hat", Excessive Engine Vibration Malfunction Test.

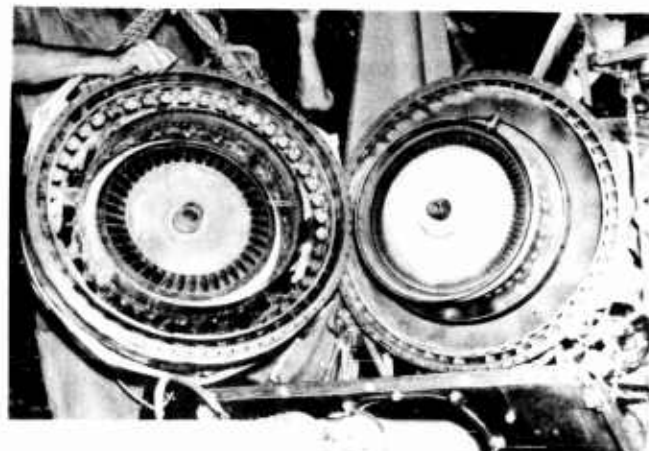
Figure 29. Combustion Chamber (N2 Turbine) Disassembly, Turbine Wheel Rotation Unbalance Test.

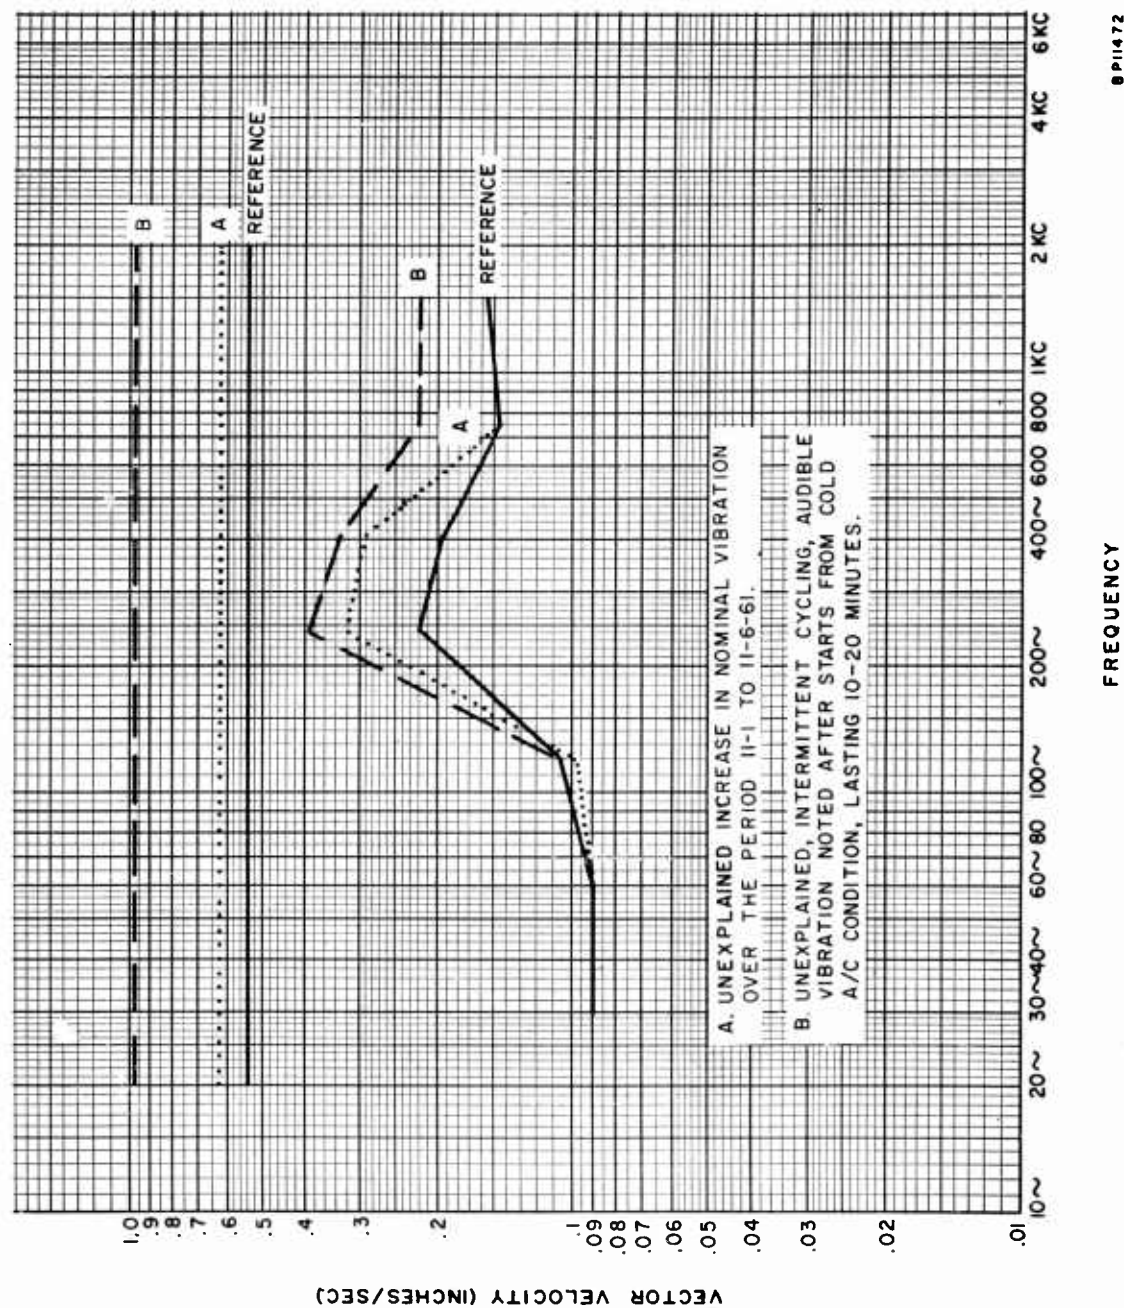
FIGURE 36. PLOT, UNEXPLAINED INCREASE IN NOMINAL VIBRATION AND INTERMITTENT CYCLING, AUDIBLE VIBRATION

able to accumulate complete data on this condition, which is presented in Figure 36. Also illustrated on this graph is another unresolved condition which occurred; specifically, an increase in the nominal or reference vibration levels just prior to the end of the test program. This also was indicated by the ALARM System. Both of these conditions (Figure 36 A and B) may be directly related, and the overhaul report should provide valuable information to resolve this phenomenon.

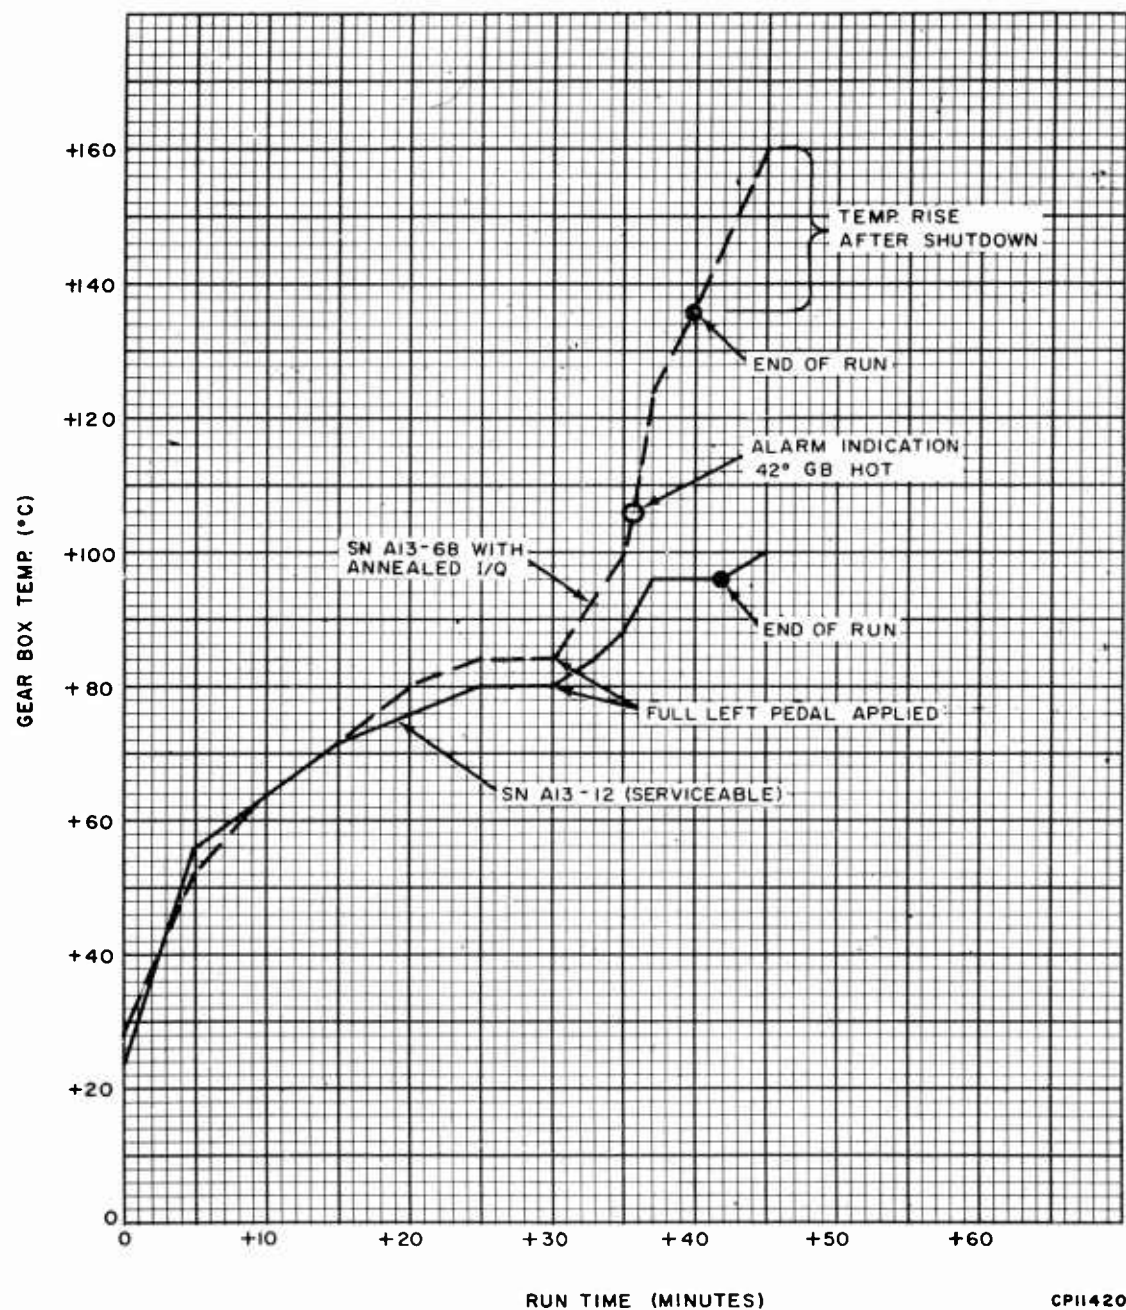
FIGURE 37. MALFUNCTION TEST #8, ANNEALED INPUT QUILL (42° 6B)

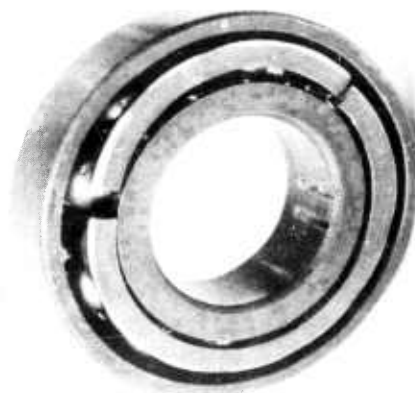
Figure 39. 42° Gear Box Input Quill Bearing Retainer Failure.

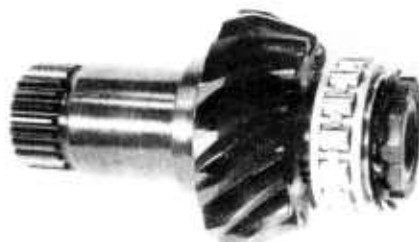
Figure 40. 90° Gear Box Input Quill Gear/ Bearing Prior To Annealing.

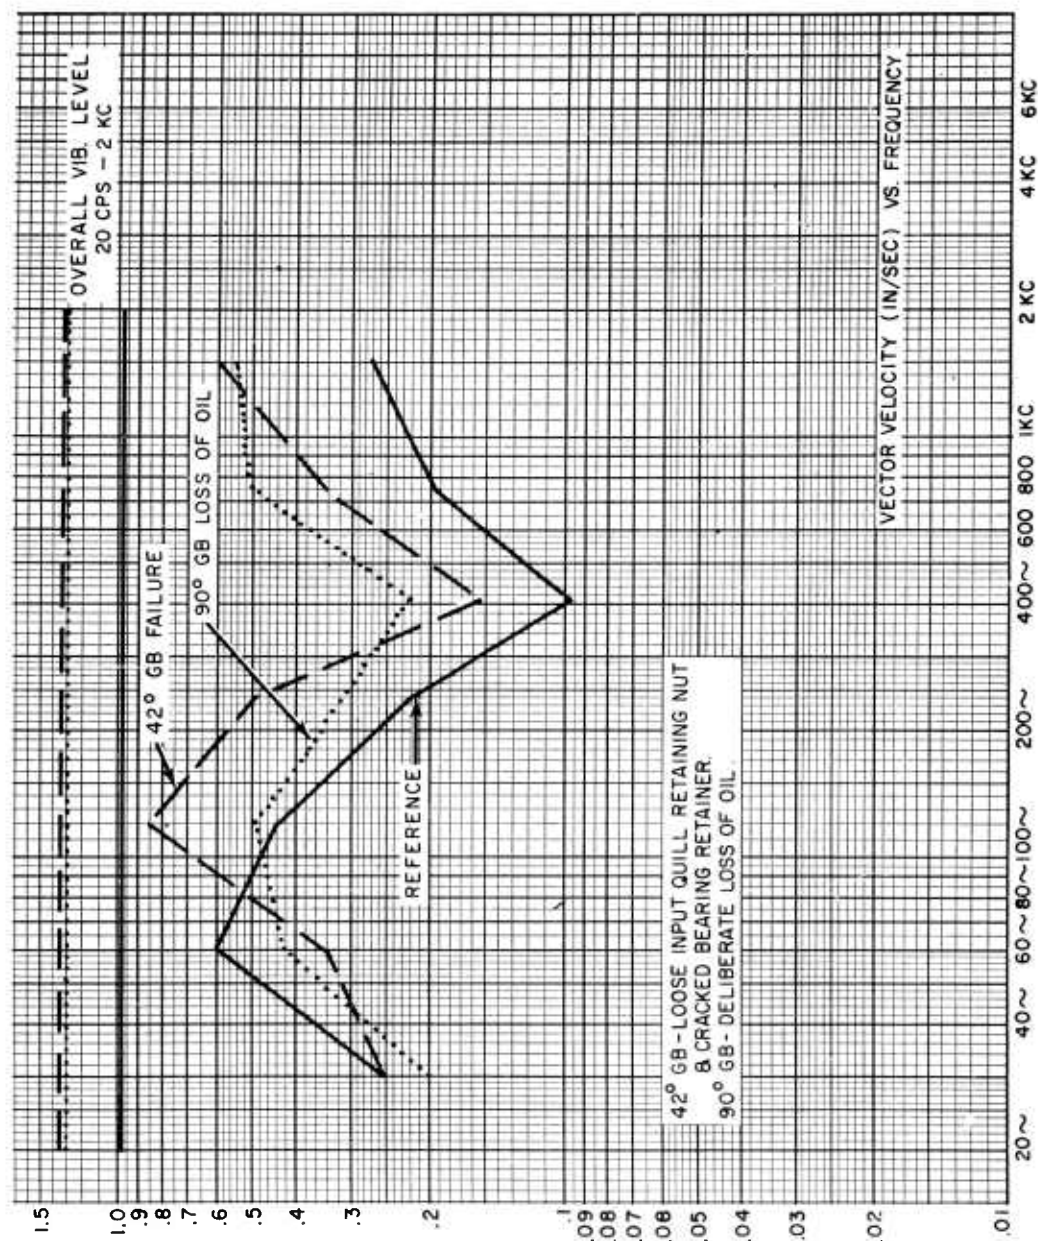
FIGURE 41. TAIL VIBRATION, INDICATED FAILURES

ALARM Tail Vibration channel indicated "NO GO". Other tests were in progress when this first occurred, resulting in about 2 more hours of running time during which recorded vibration levels continued to increase. At this time, an abnormal grinding noise was audible from the gear box, particularly on coast-down. Subsequent disassembly and inspection revealed both a loose bearing retaining nut and a failure of the inner bearing retainer, as shown in Figure 39. It is difficult to conclude when complete failure occurred. Apparently it took place after 5 hours, and the continued increases in vibration were caused by progressive deterioration of the bearings. The data associated with this test are shown in Figure 41. It is not certain whether the heat-treating process (to accelerate wear) caused this failure directly or indirectly by causing the retaining nut to become loose. Of more significance is the effect this condition had on tail vibration, particularly on increasing higher frequencies while actually decreasing levels at the lower frequencies. No indication was noted in chip detection during this sequence, probably because of its location (see discussions under Test #15).

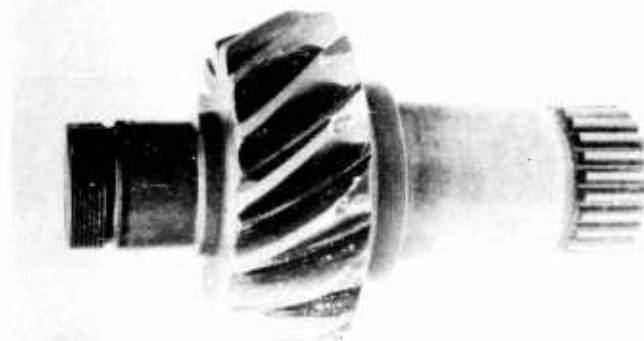
Figure 42. 90° Gear Box Input Quill (Gear after Test #9, heat treated to 1/2 hardness).

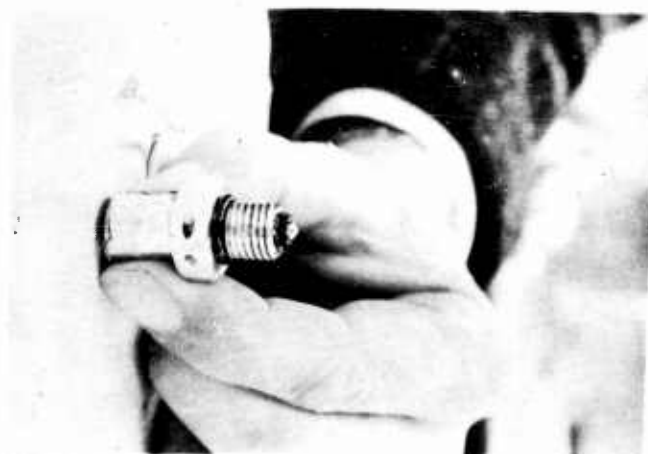
Figure 43. 90° Gear Box Magnetic Chip Detector After Test #9 (Magnetic chip detector accumulation).

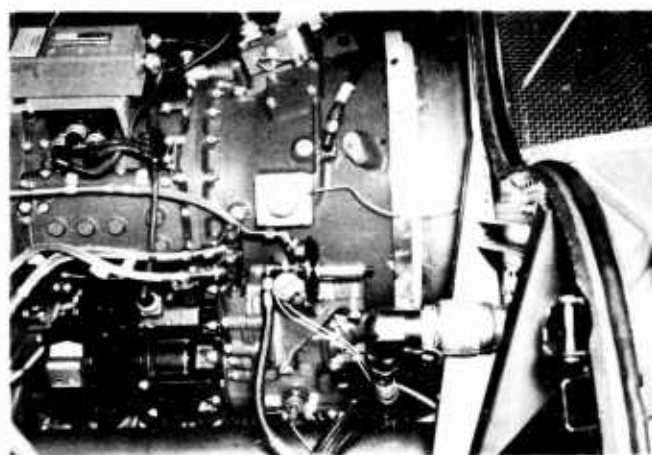
Figure 54. Engine View Showing Blocked Oil Filter Installed.

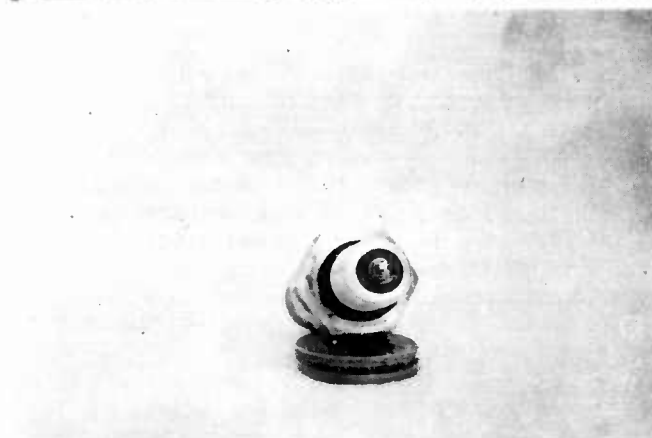
Figure 55. 90° Gear Box Chip Detector Prior To Installation.

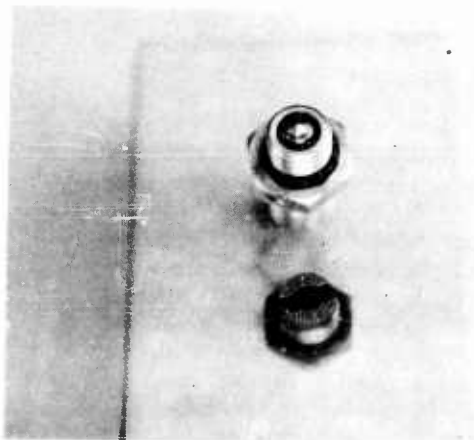
Figure 56. 42° Gear Box
Chip Magnetic Detector
And Magnetic Plug.

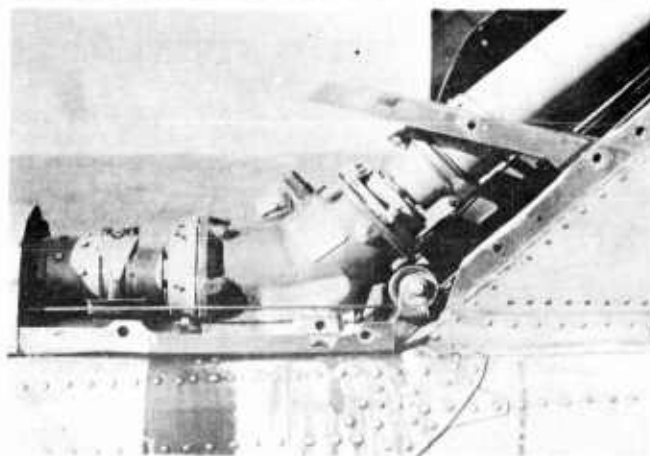
Figure 60. 42° Gear Box
Showing Relocated Chip
Detector Provision.

It is also recommended that the magnetic chip detectors for the main transmission and the 42⁰ gear box of the HU-1A aircraft, be relocated in accordance with the finding of this report. In addition, it is recommended that the filter bypass setting be changed from the present 50% bypass flow to indicate bypass valve opening.

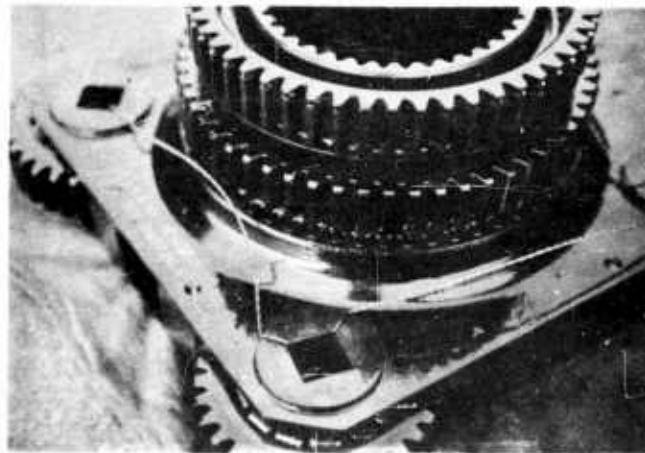
Figure 67. Upper Planetary Bearing Retainer Failure.

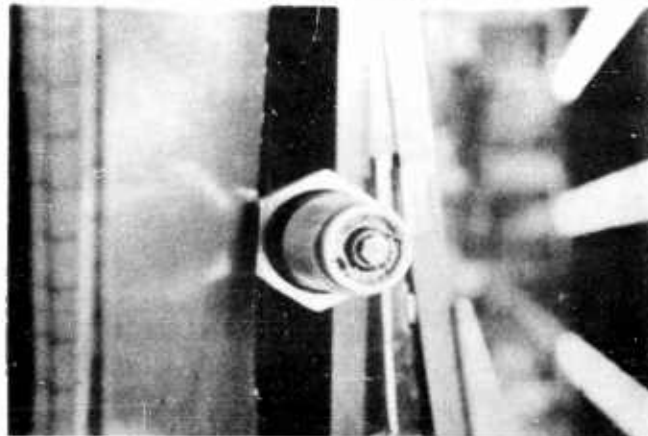
Figure 68. Main Transmission Chip Detector After Addition Of 1 Gram Of Particles.

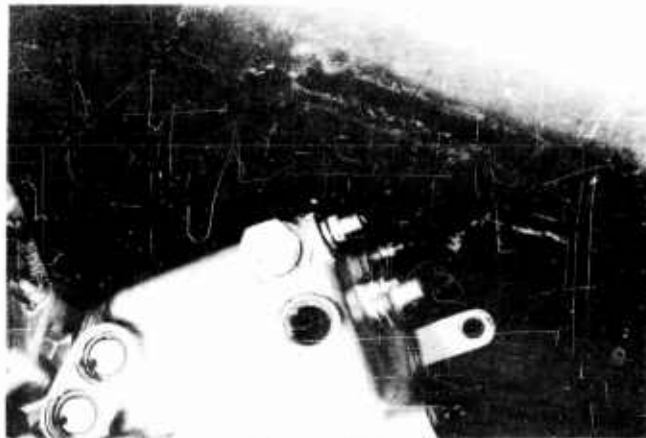
Figure 71. Relocated Main
Transmission Chip Detector.
